IRVING POND DAM

FULTON COUNTY, NEW YORK INVENTORY NO. N.Y. 174

PHASE I INSPECTION REPORT NATIONAL DAM SAFETY PROGRAM

NEW YORK DISTRICT CORPS OF ENGINEERS FEBRUARY, 1979

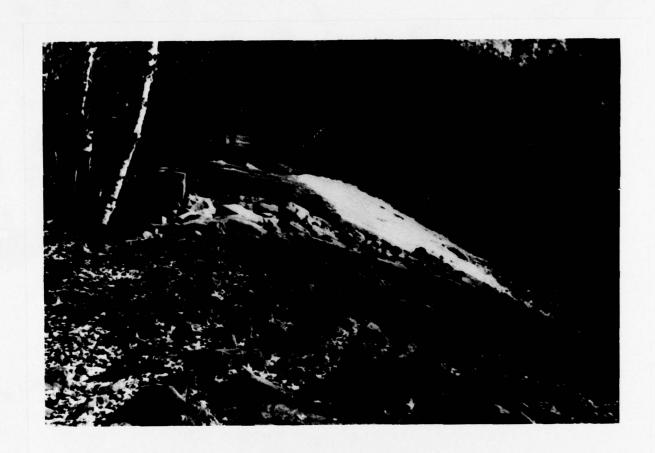
Overview of Irving Pond Dam Looking South

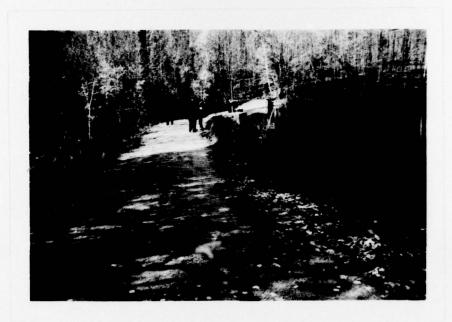
The earth embankment shows no sign of distress. The vertical and horizontal alignment of the crest appears to be good with no visible cracks on the embankment slopes or crest. There is no evidence of sliding, sloughing and depressions. The top of the south embankment is exposed earth while the same on the north embankment is heavily riprapped. Slopes are also protected by heavy riprap. There is considerable growth of vetetation on the upstream side of embankment and there is debris and trees around the walls of the low-level outlet and at both abutments. The two abutment walls have cracked exposing sheet piles. Seepage was observed at different locations at the toe of the spillway. However, the seepage water was clear and there was no evidence that fine materials were being carried away. The spillway and the toe of the dam should be observed under no flow conditions to determine the source of the observed seepage. The seepage could be related to spillway flow since the grouted riprap downstream face also serves to transport spillway flow.

Top of Dam Looking North

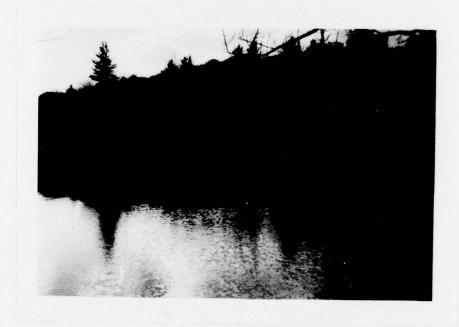
Upstream face of dam

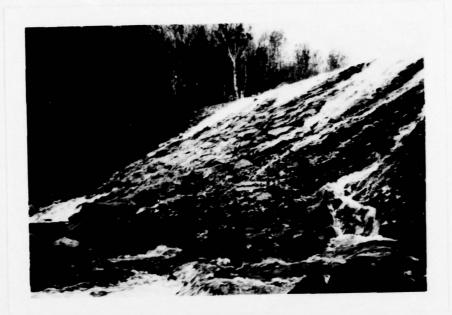
Downstream face of dam Looking North

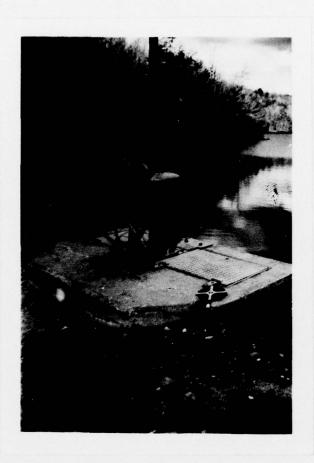
Sluice Gate Mechanism

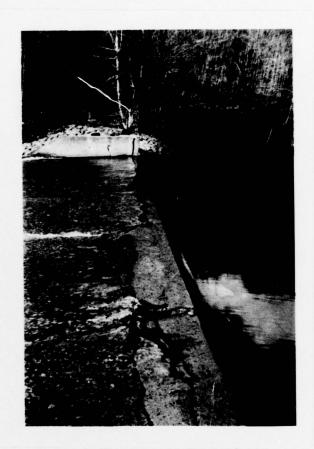
The visual observations did not indicate any sign of major distress in connection with earth embankment. The spillway, however, is in poor shape. The spillway slab cracked and spalled in many places exposing reinforcement bars. Cracks separated the two end walls and the spillway slab from the sheet pile along the entire width of the spillway. There are a number of voids underneath the spillway, the biggest one is about 4 feet in diameter and 5 feet deep. Water flowing through the cracked south end wall is scouring the embankment.

Spillway Looking North note cracked and spalled concrete resulting from sheet piling

a. Results of the aforementioned investigations will determine the remedial measures required for the spillway and the control of the observed seepage.

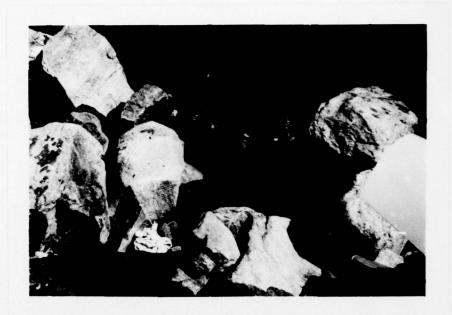
There is no operation and maintenance manual for the project. The embankment is in good shape. The broad crested reinforced concrete spillway slab is broken in many places; separation of spillway slab and sheet pile is complete. Both abutment walls cracked open exposing sheet piles. There are a number of voids underneath the spillway. The biggest one (about 4 feet in diameter and 5 feet deep) being near the north abutment wall (end wall).

The spillway is in poor shape and needs repairs. It is possible that the timber crib has deteriorated, resulting in the displacement of stones and creation of voids underneath the spillway slab.

Void under north wall of spillway

The spillway is not considered unsafe at this time. However, a thorough investigation of the spillway foundation should be conducted to determine the extent of the voids and the stability of the spillway.

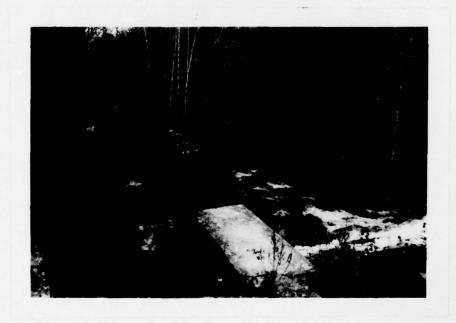
Downstream area looking west

Investigate the conditions of seepage encountered at the toe of the dam. This investigation must be conducted under no flow conditions so that spillway flows do not mask seepage observations.

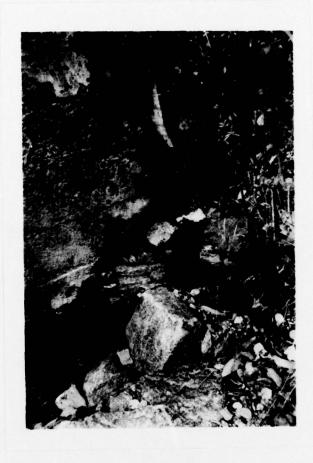
North wall of low level outlet channel note cracking of concrete

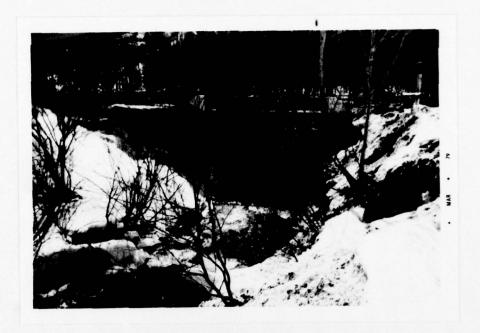
The downstream channel is riprapped and no debris was observed in the channel other than some displaced stone.

Downstream Channel - Bridge NY Rts 10 & 29A
